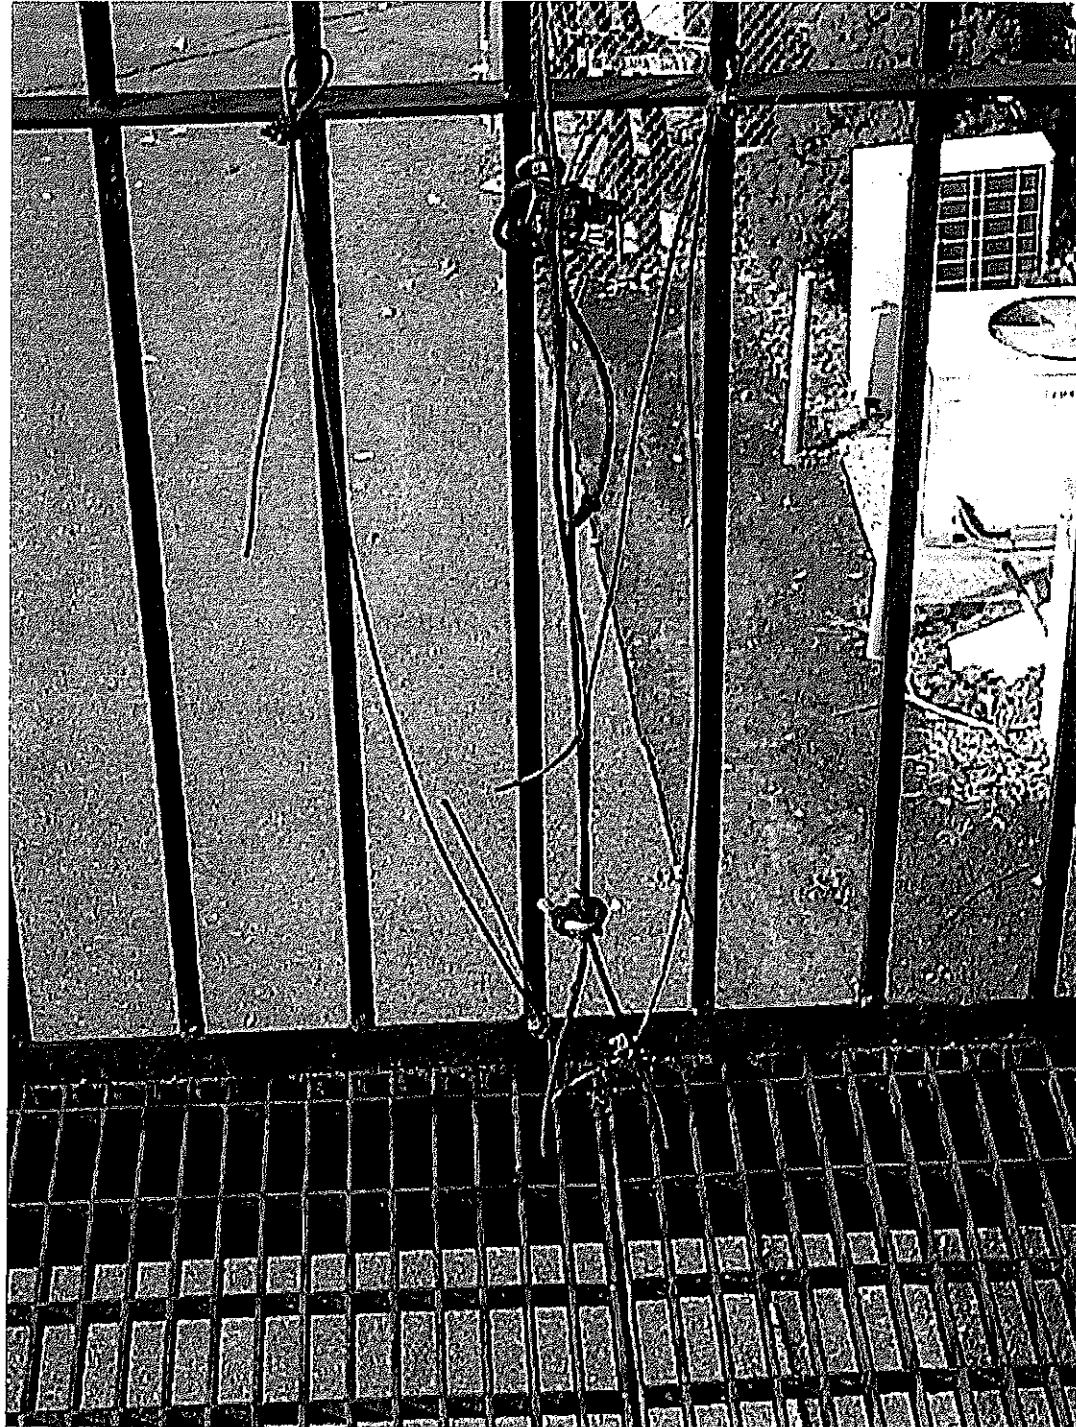
2nd floor Fire Escape:
Landing fell-repaired by welding.
Cables attached for a little extra
Safety.

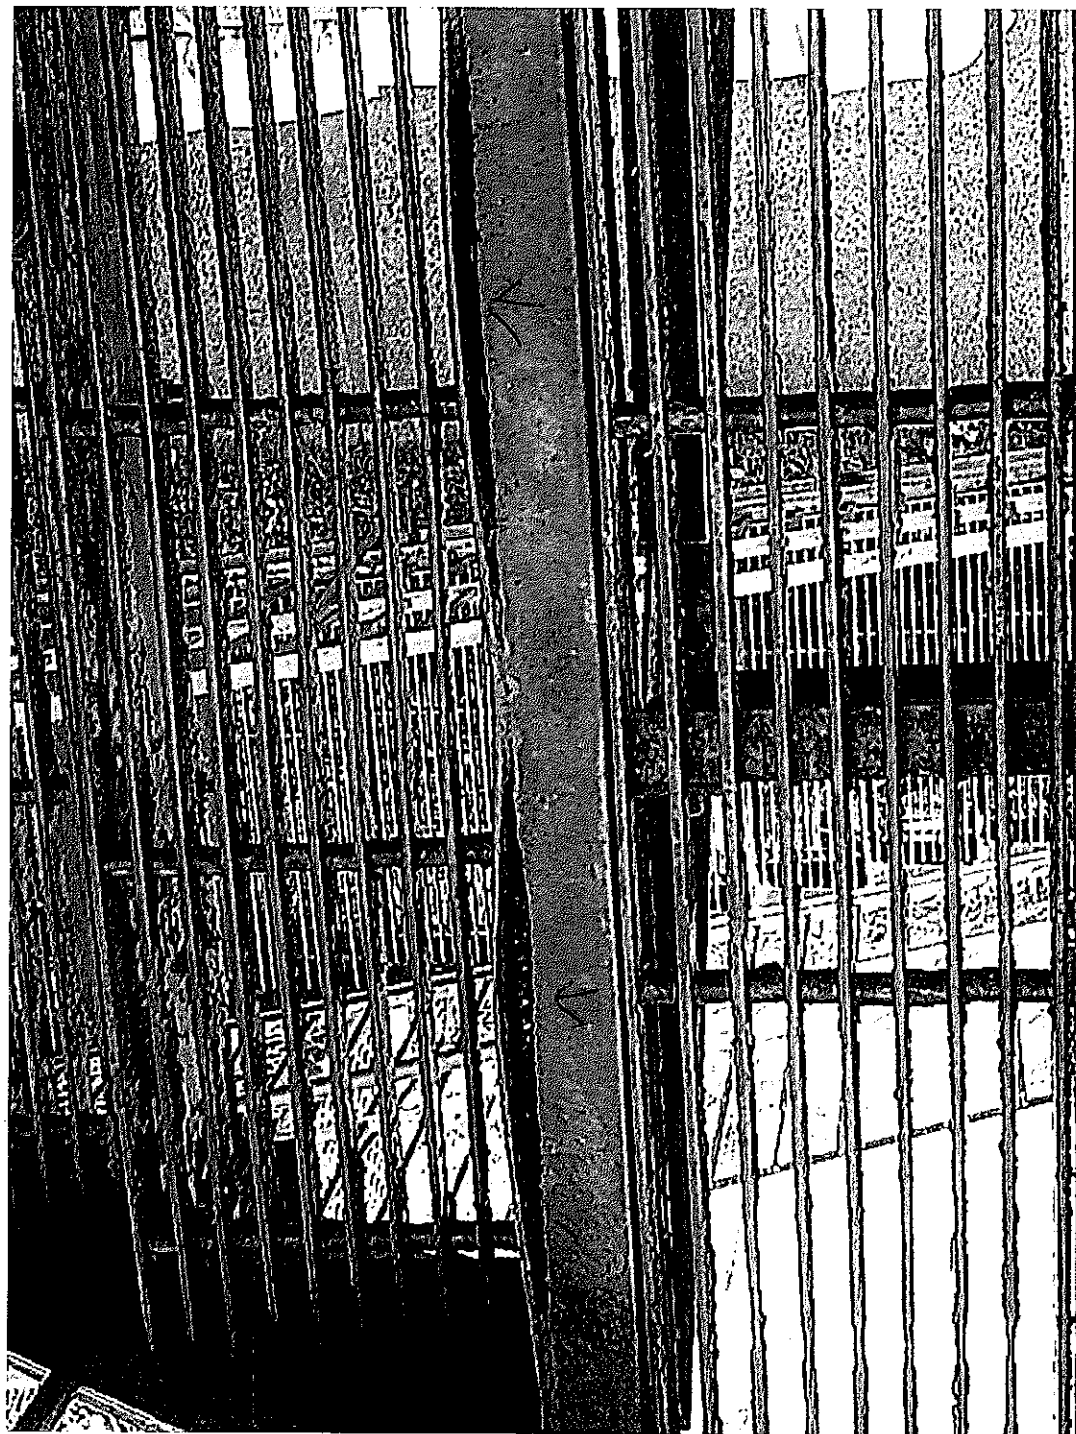
Fire escape stairs rusting away-treads separating from the frame.

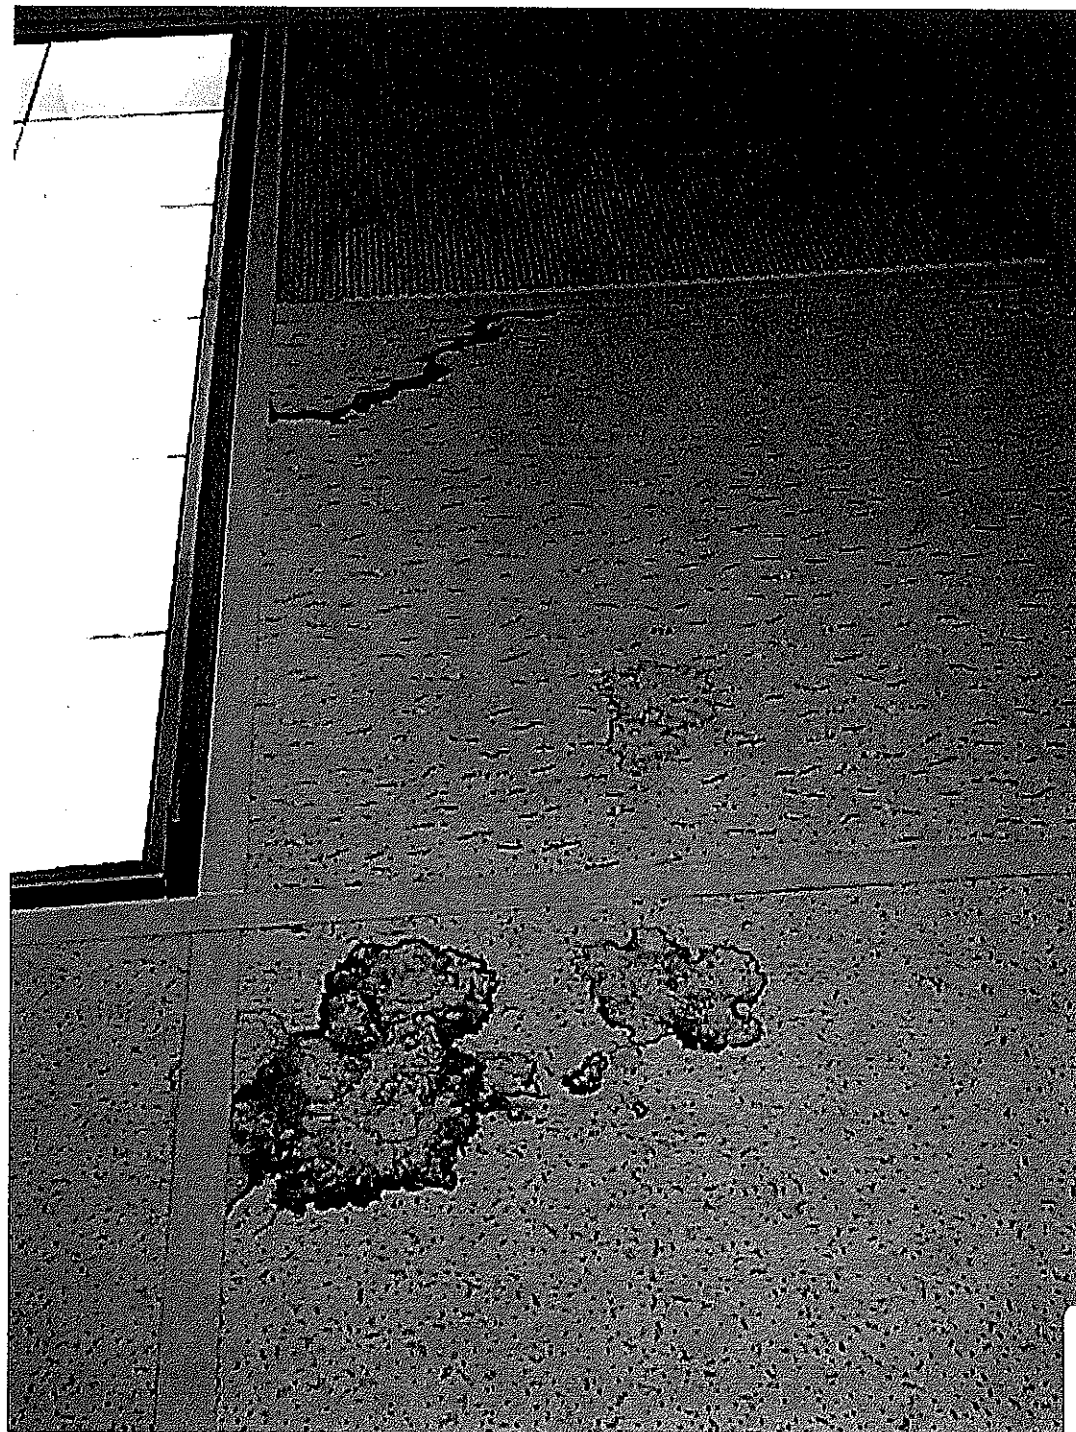
2nd floor ceiling tile water damage.

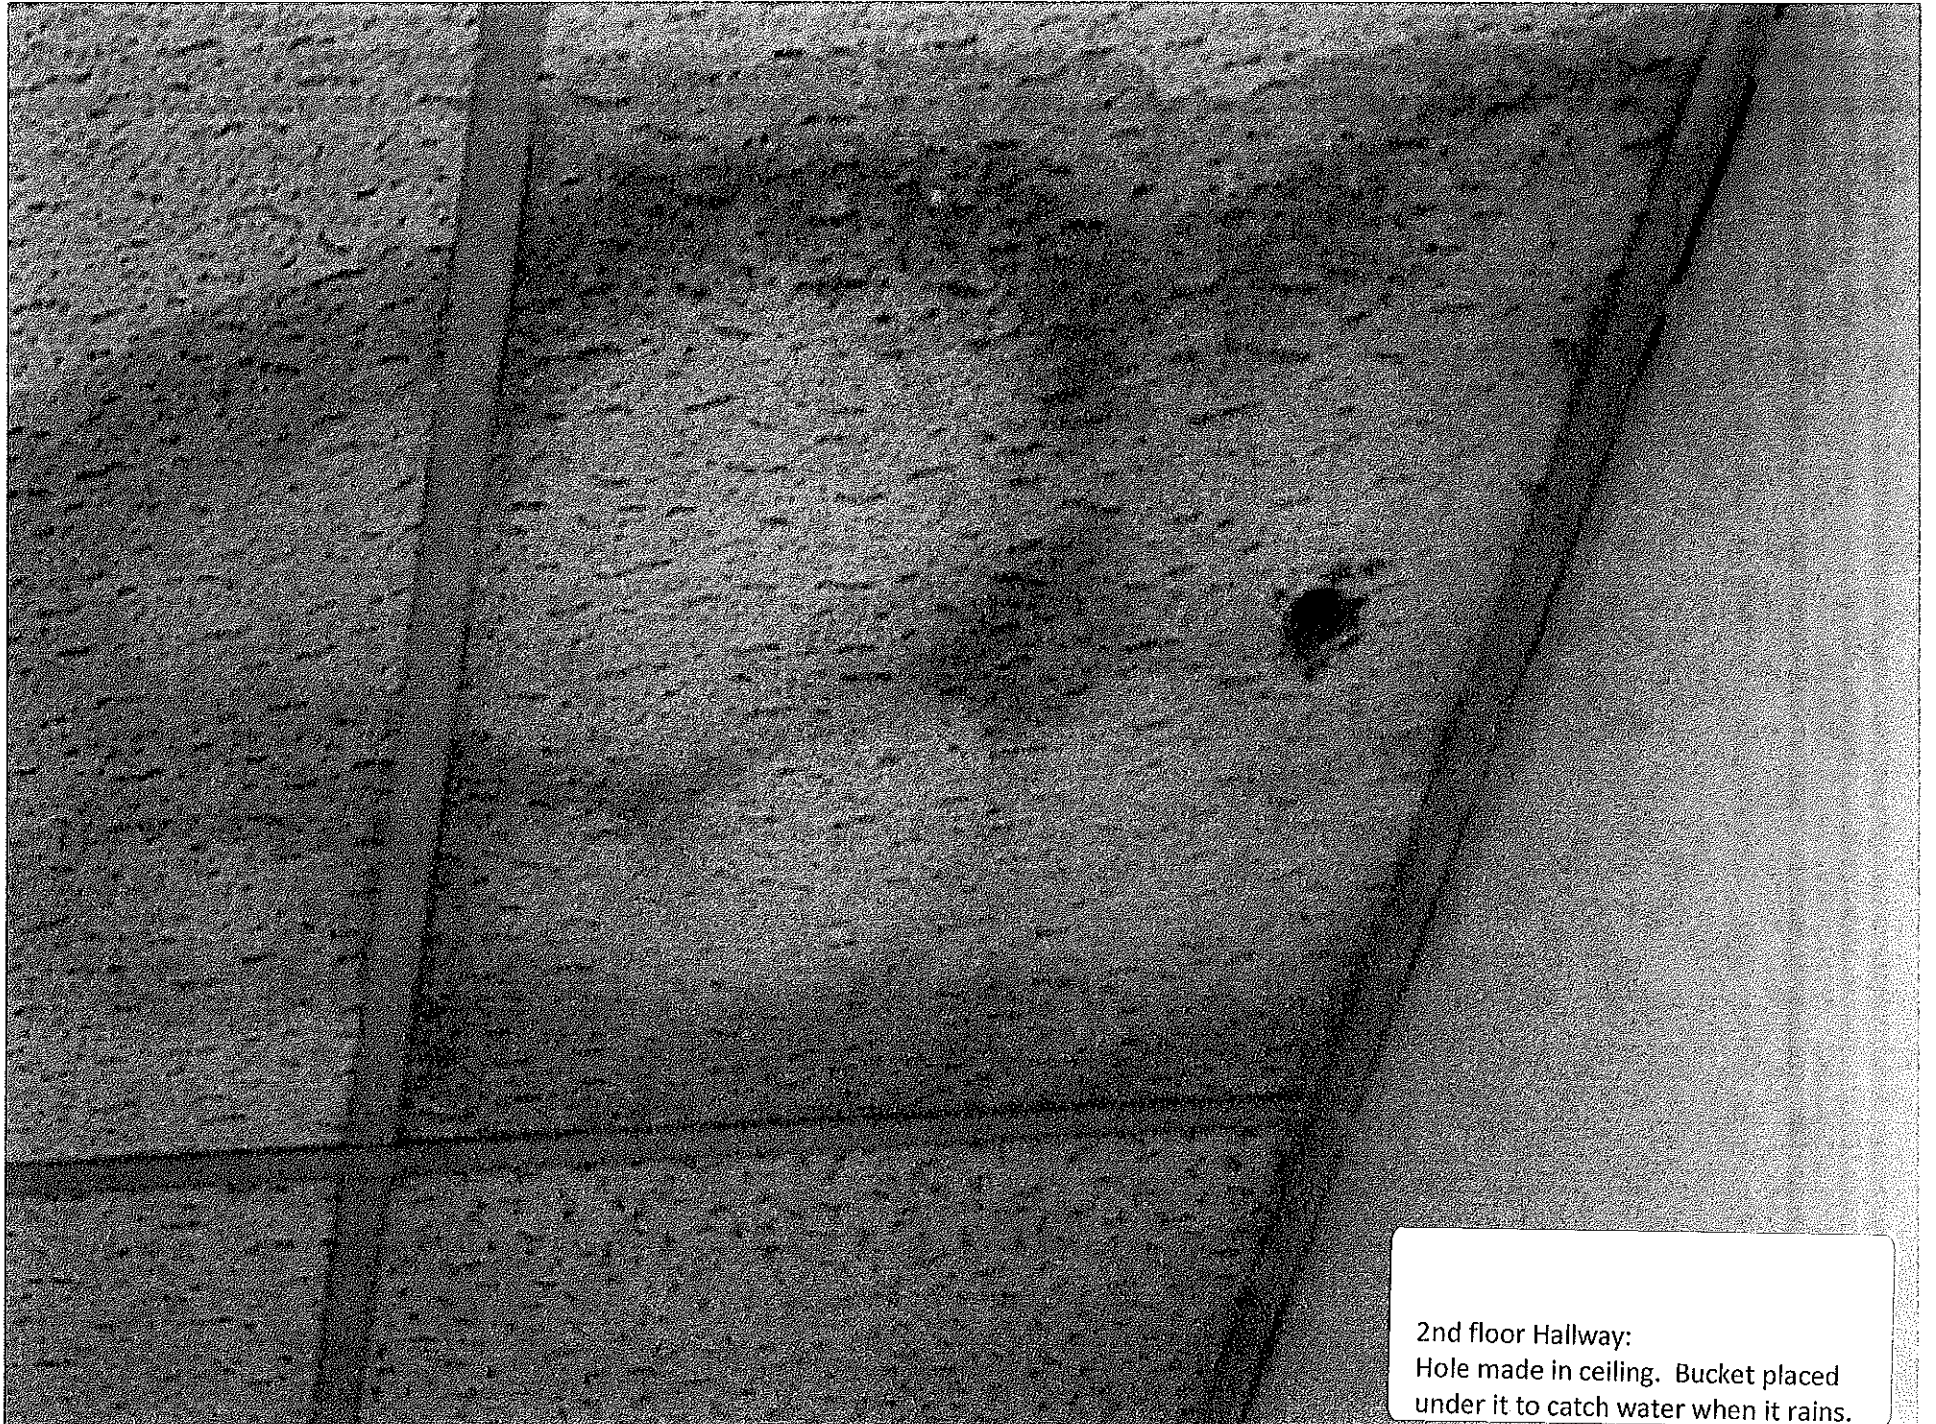
2nd floor Hallway:
Hole made in ceiling. Bucket placed
under it to catch water when it rains.

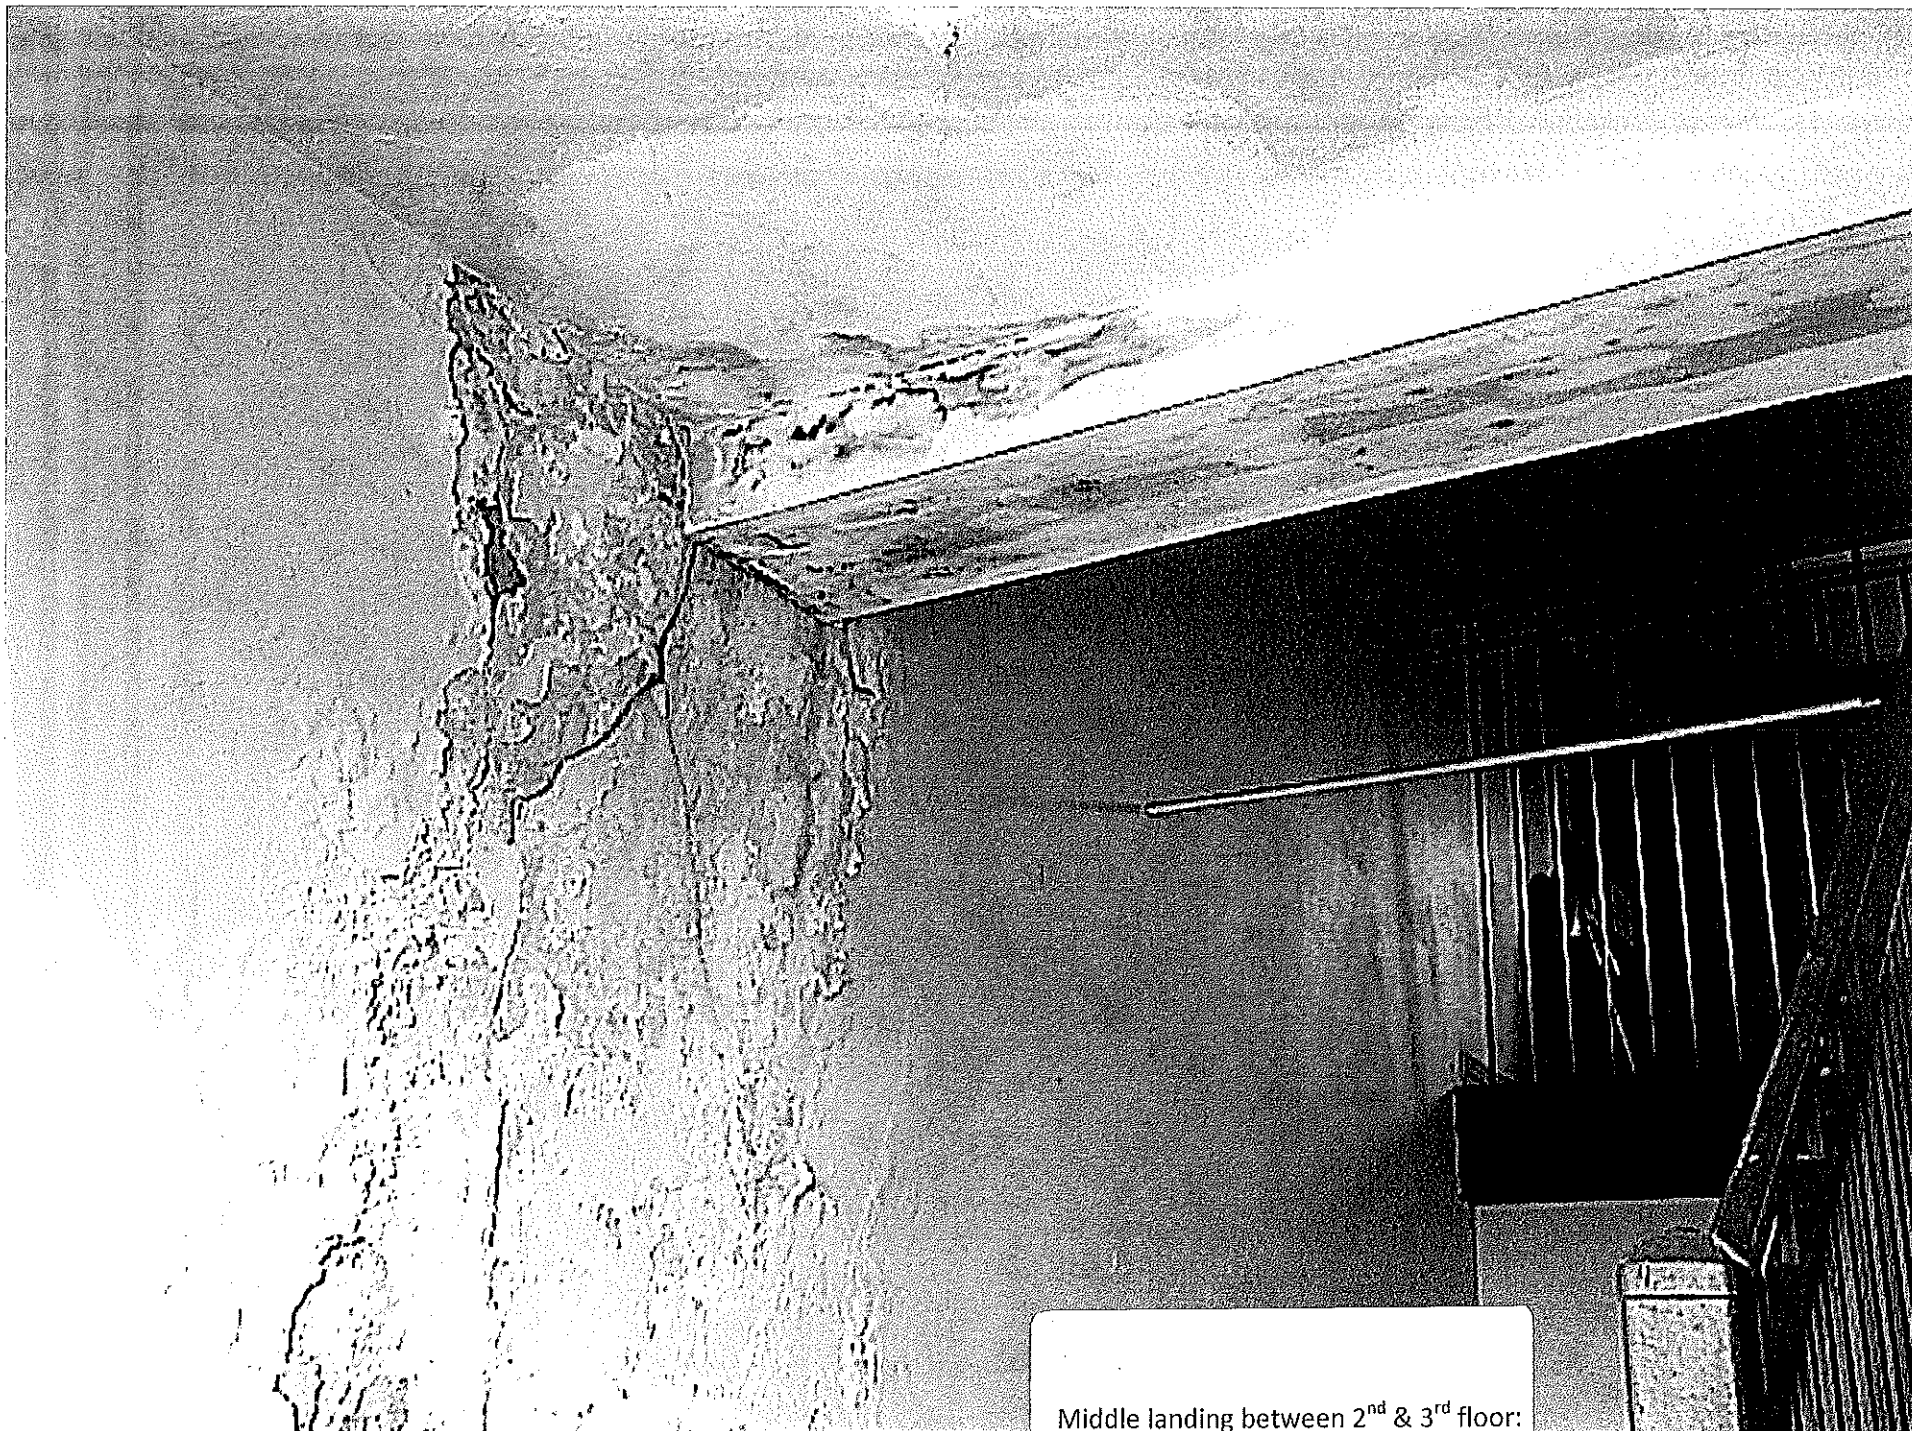
Middle landing between 2nd & 3rd floor:
Wall not repairable and mold damage
